TECHNICAL INSPECTION REPORT

6 OPERATION CROSSROADS.
U.S.S. CRITTENDEN (APA 77)

TEST ABLE.

VOLUME 2 [U].

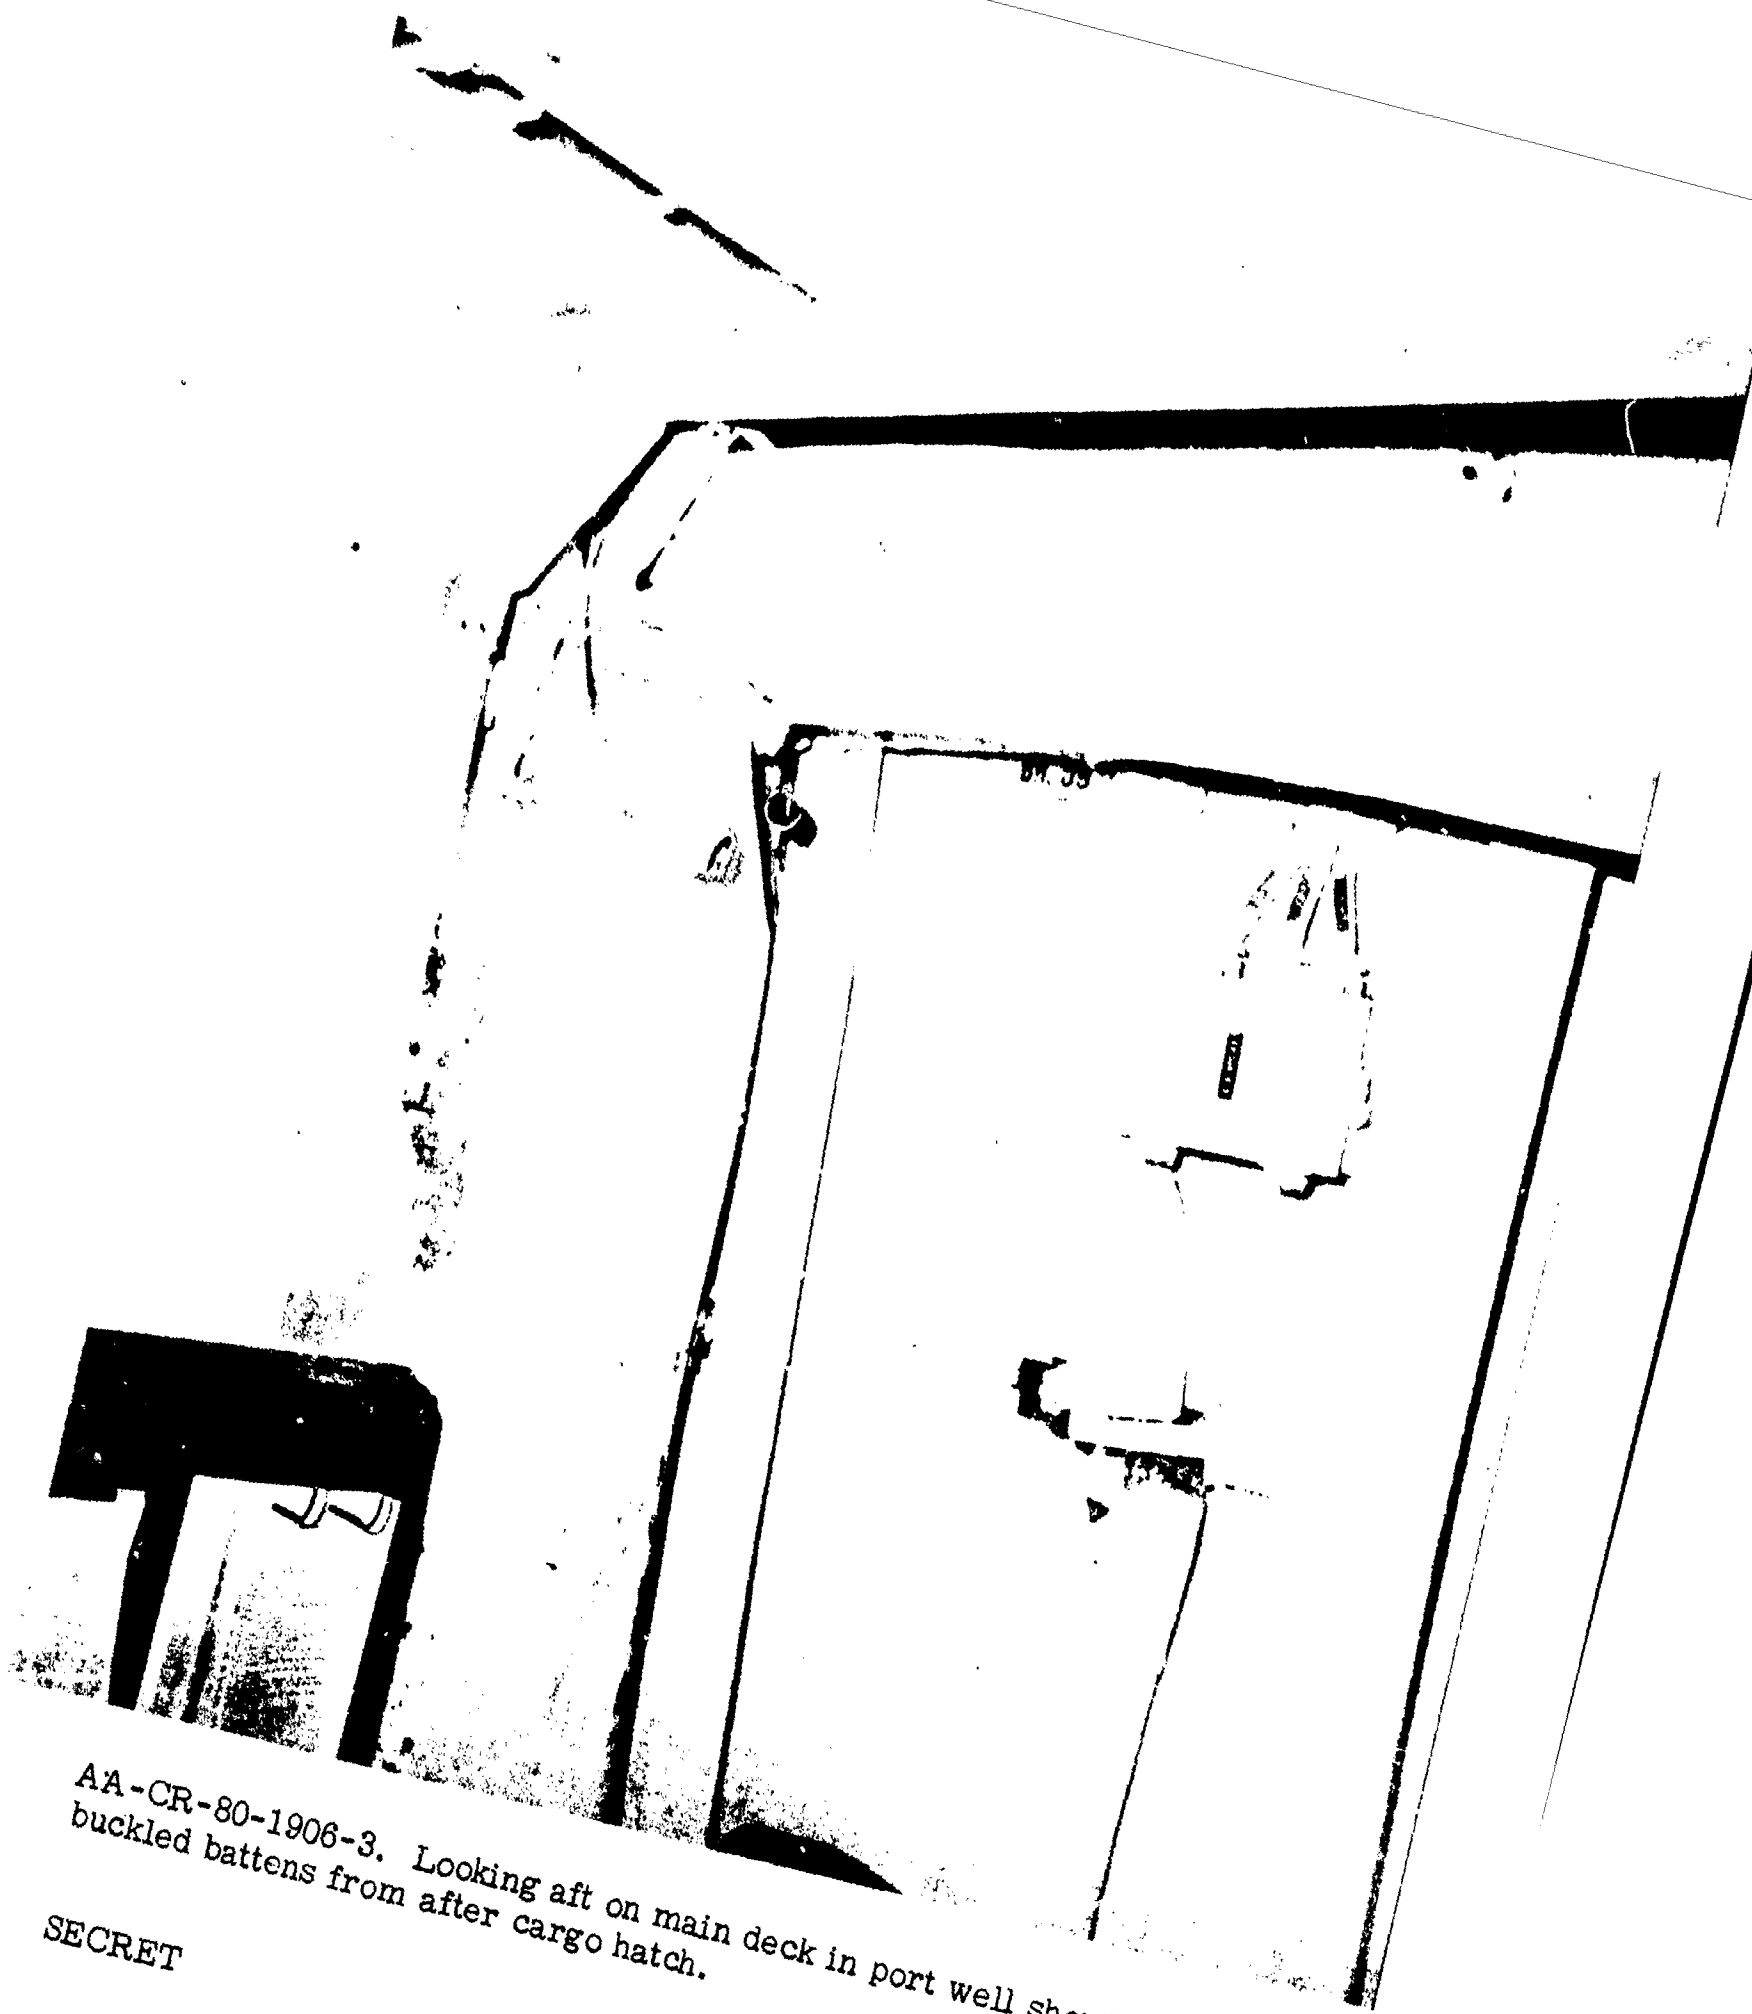
AA-CR-80-1906-3. Looking aft on main deck in port well showing buckled battens from after cargo hatch.

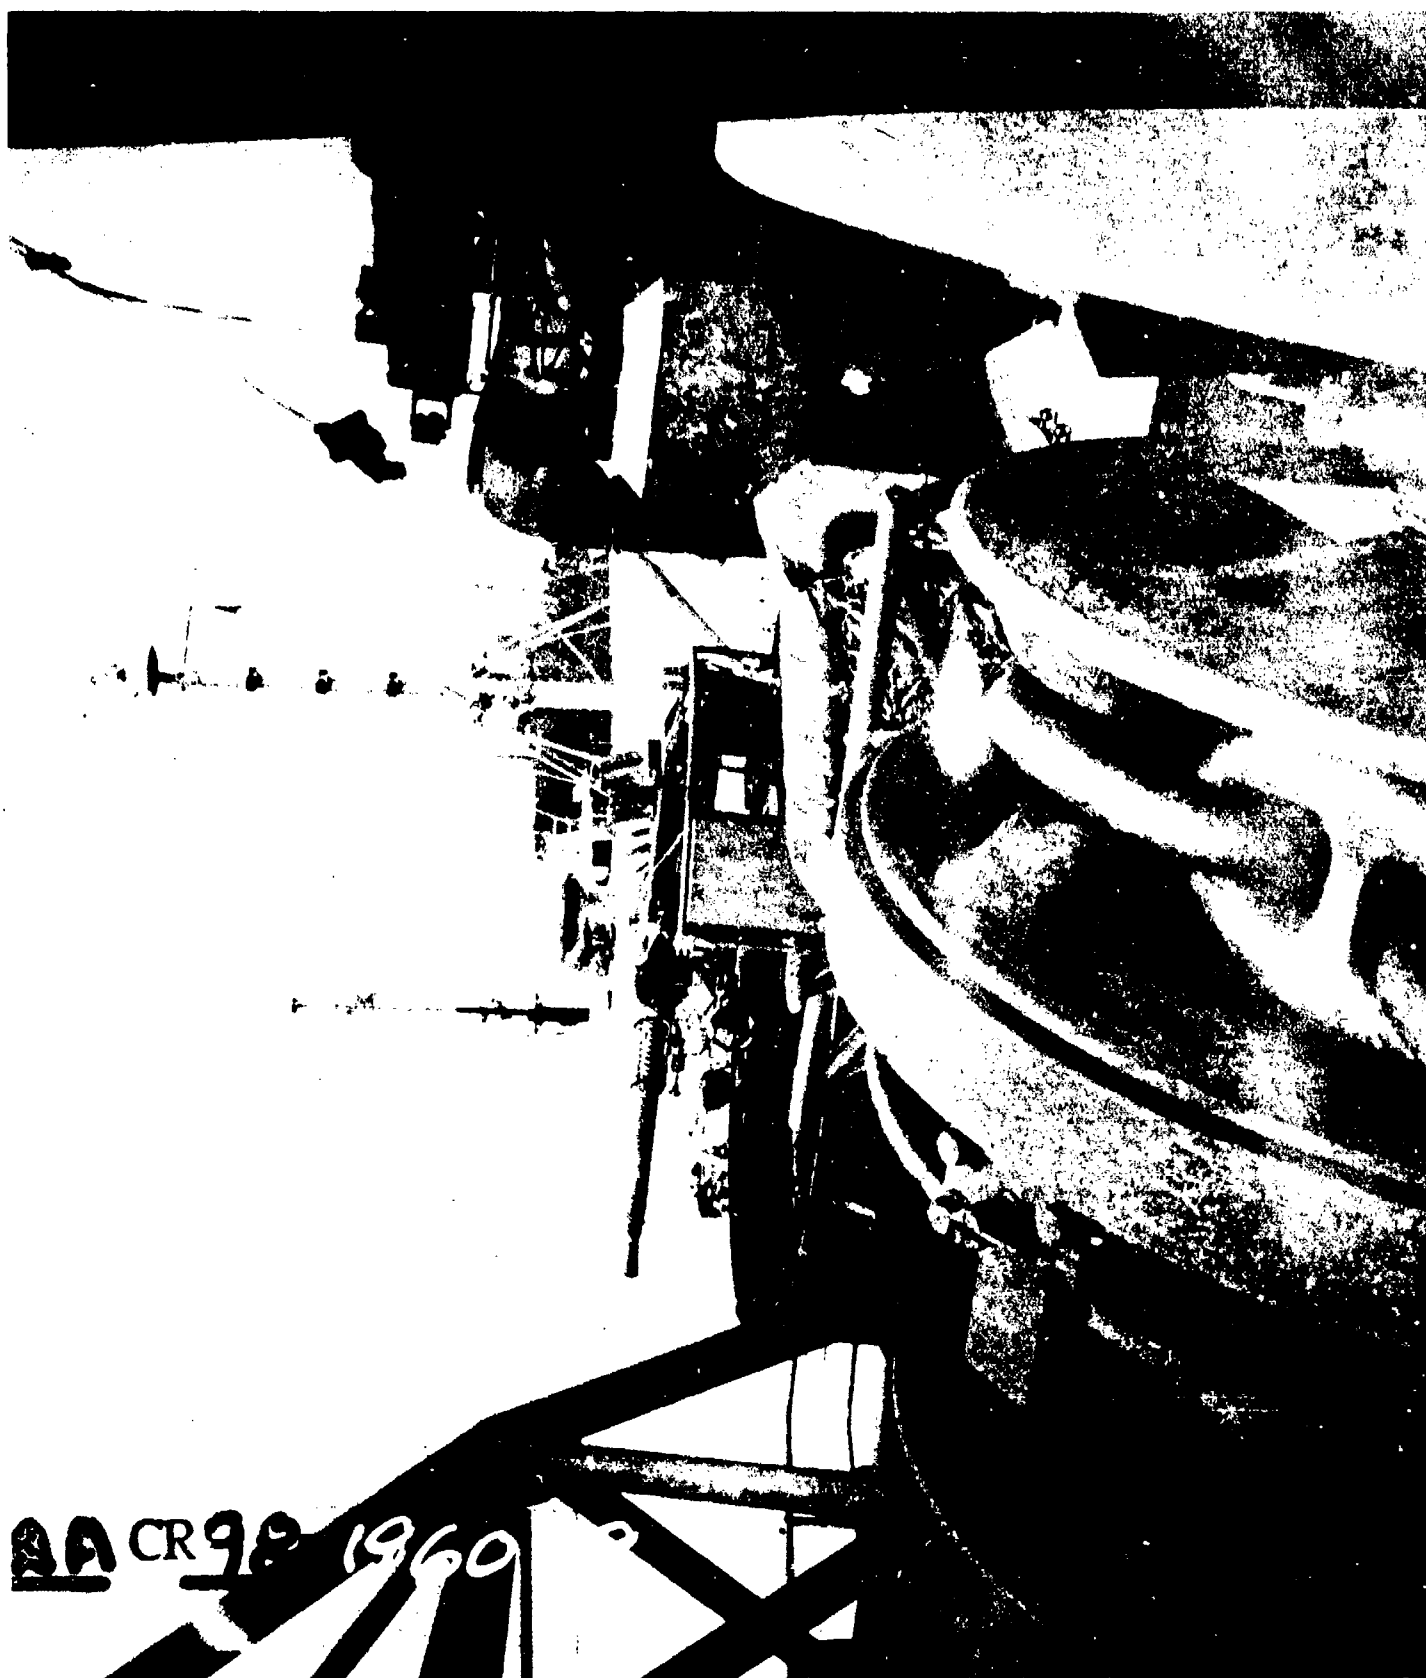
AA-CR-98-1960-9. Looking aft to starboard on upper deck from bow, showing 40mm mount.

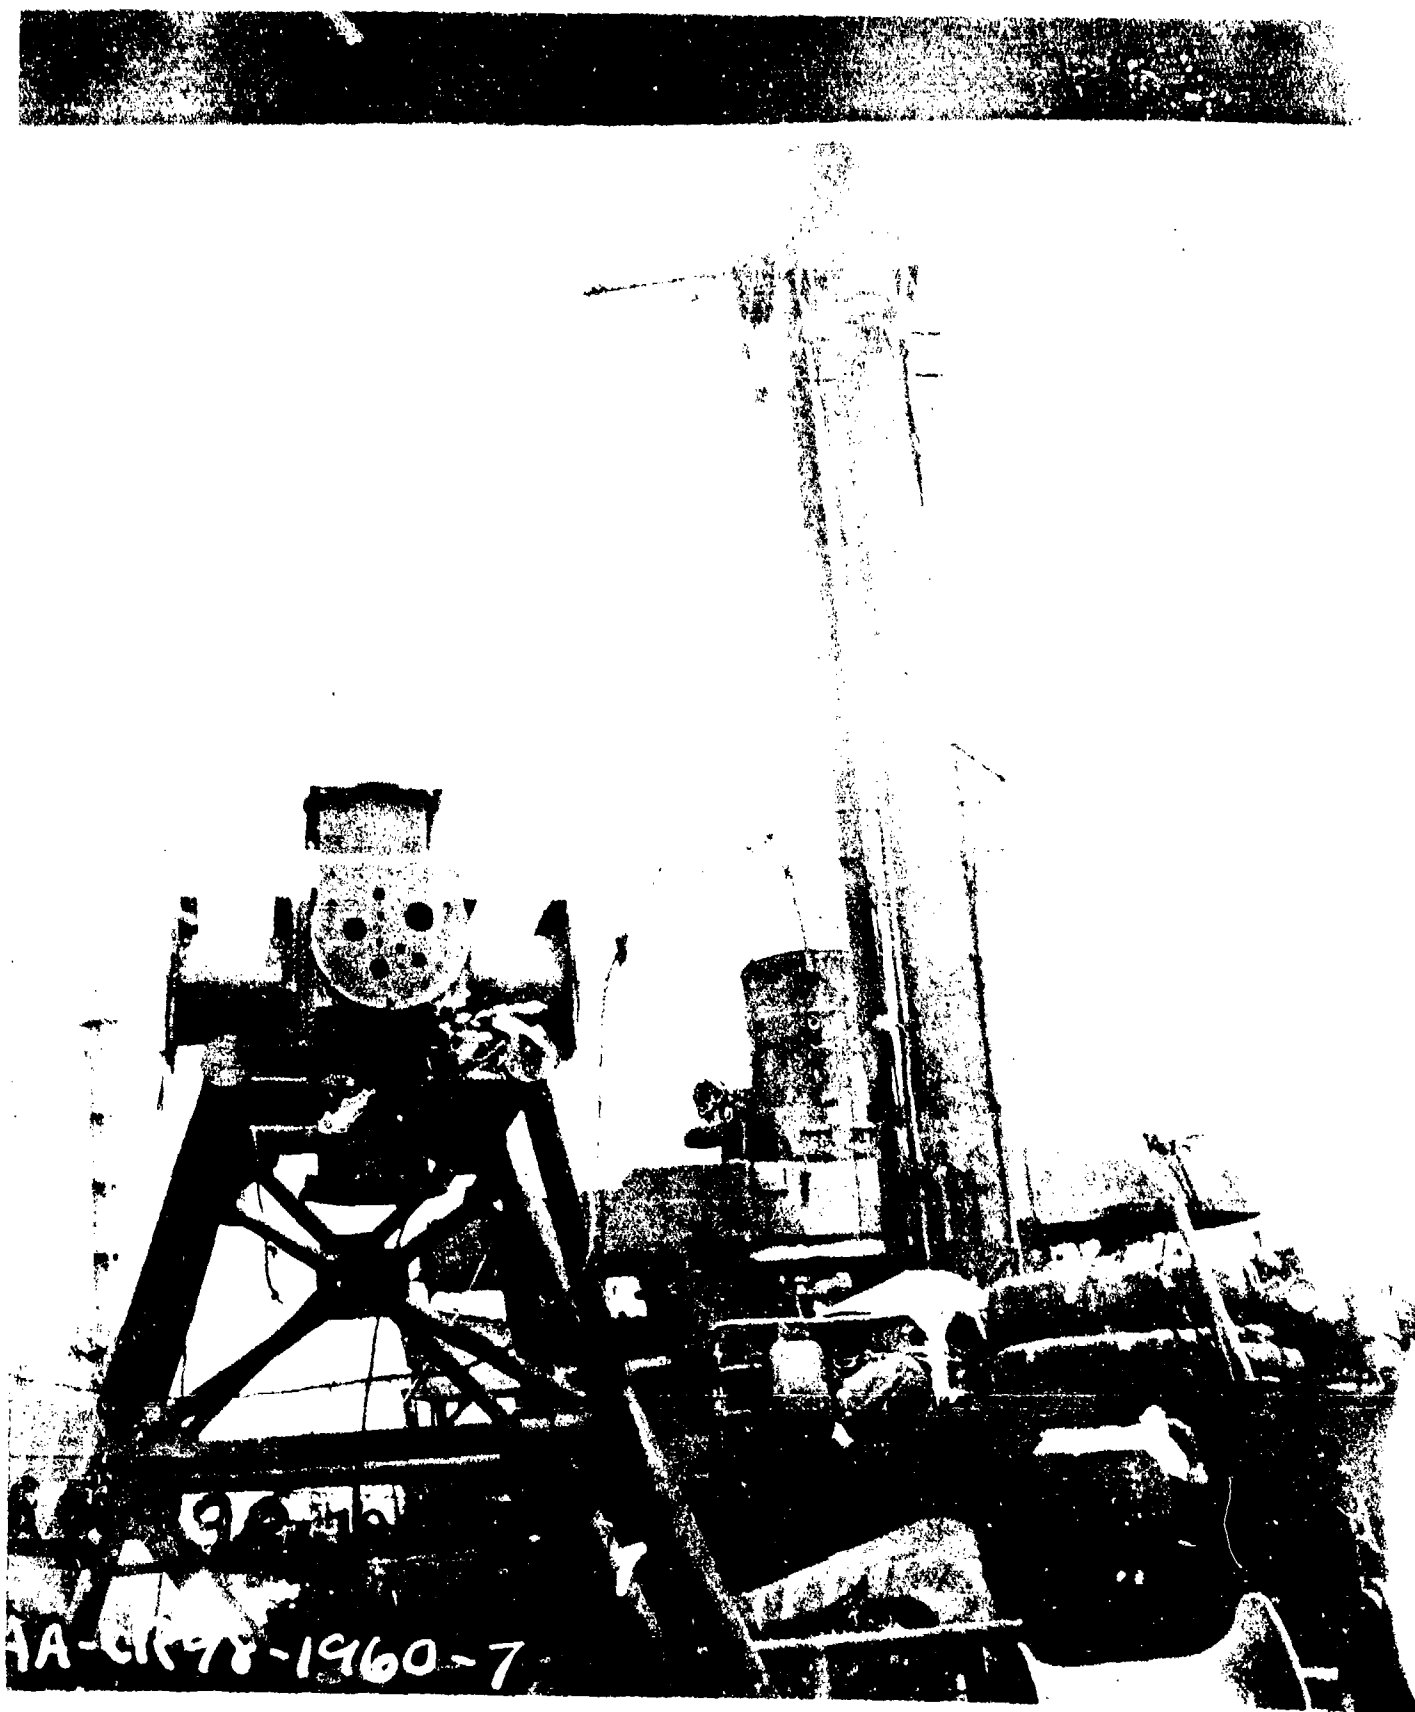
AA-CR-98-1960-7. Looking aft on upper deck from bow.

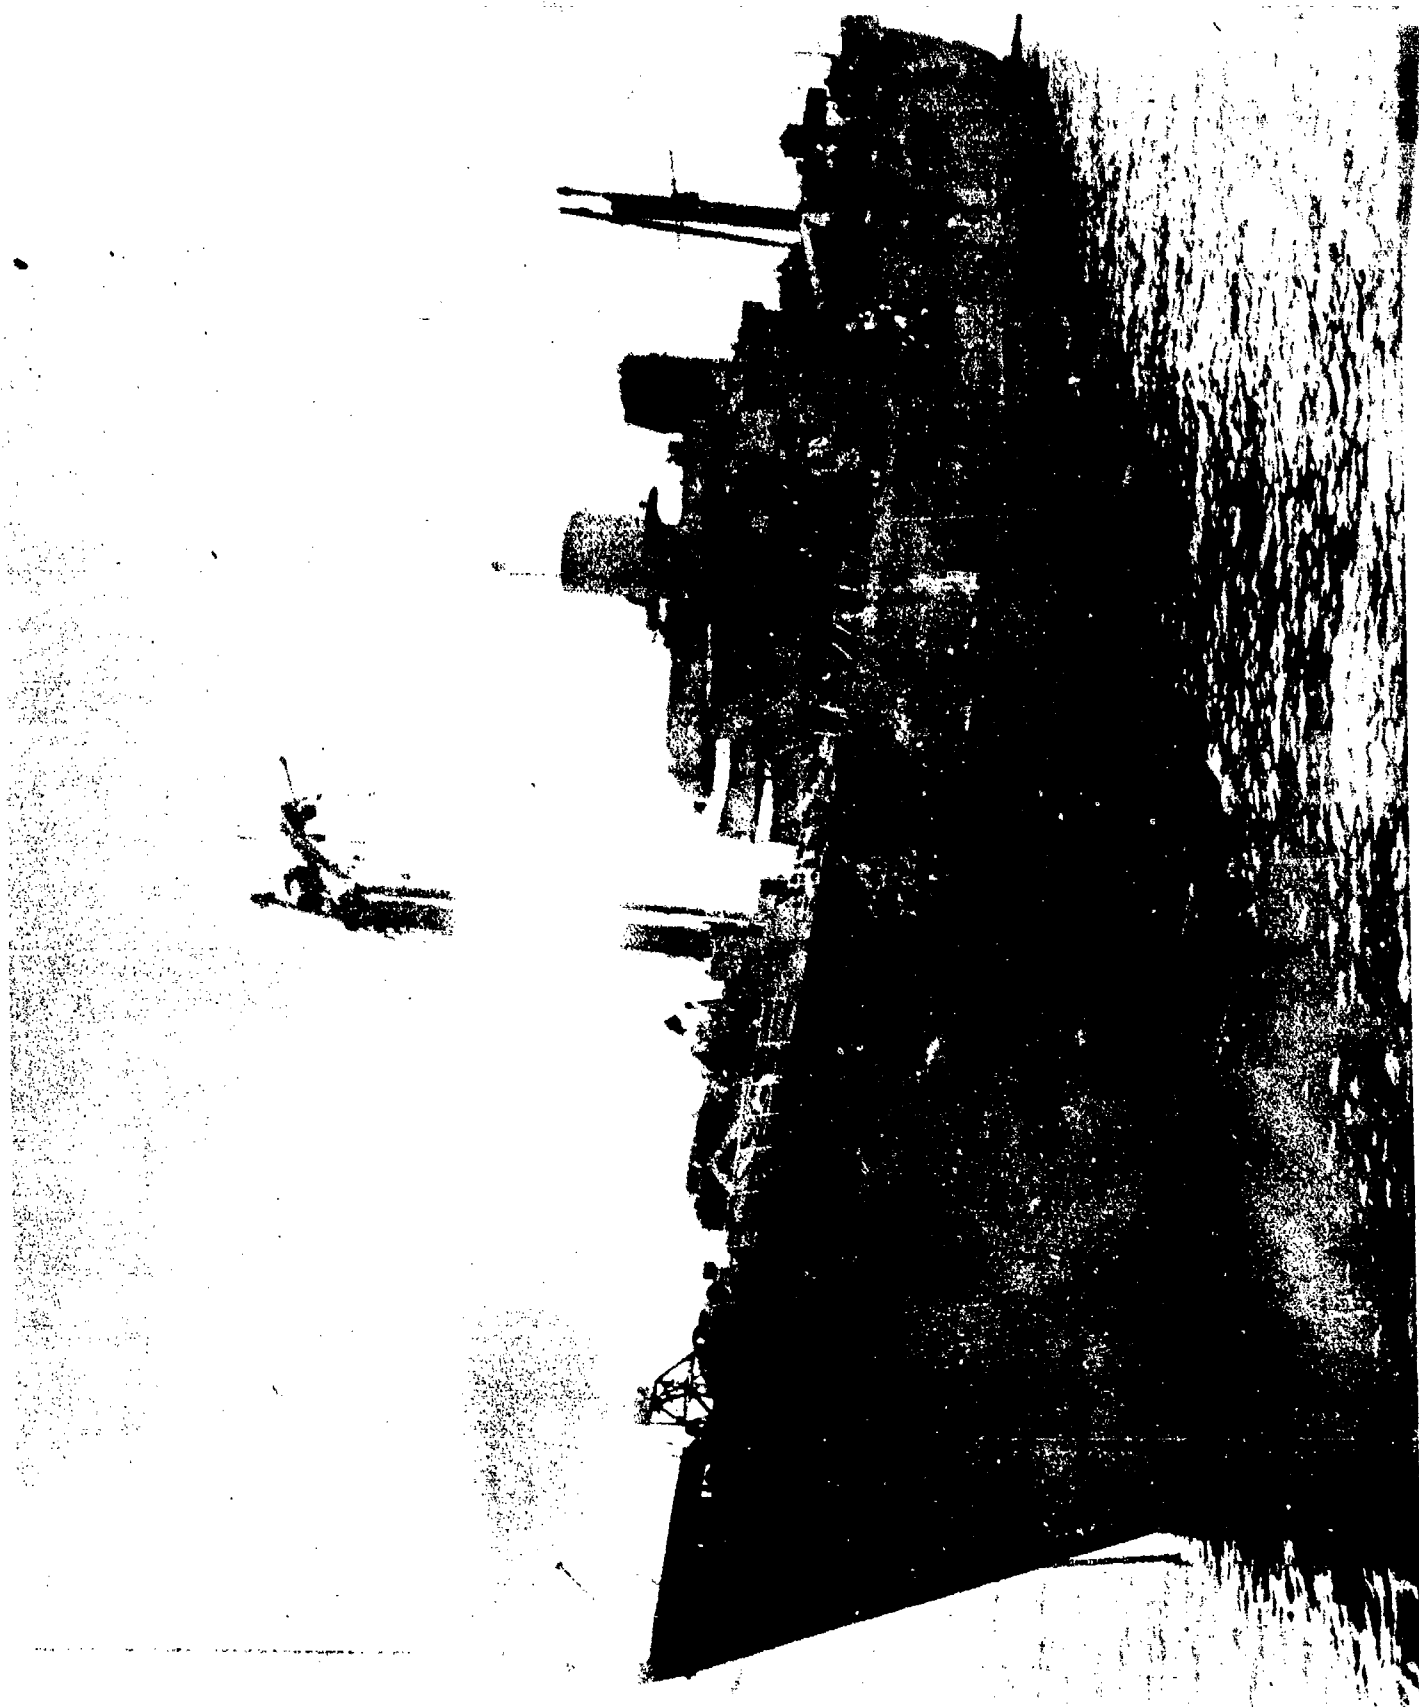
AA-CR-98-1962-4. View from off port bow notice life stowage on fore-castle.

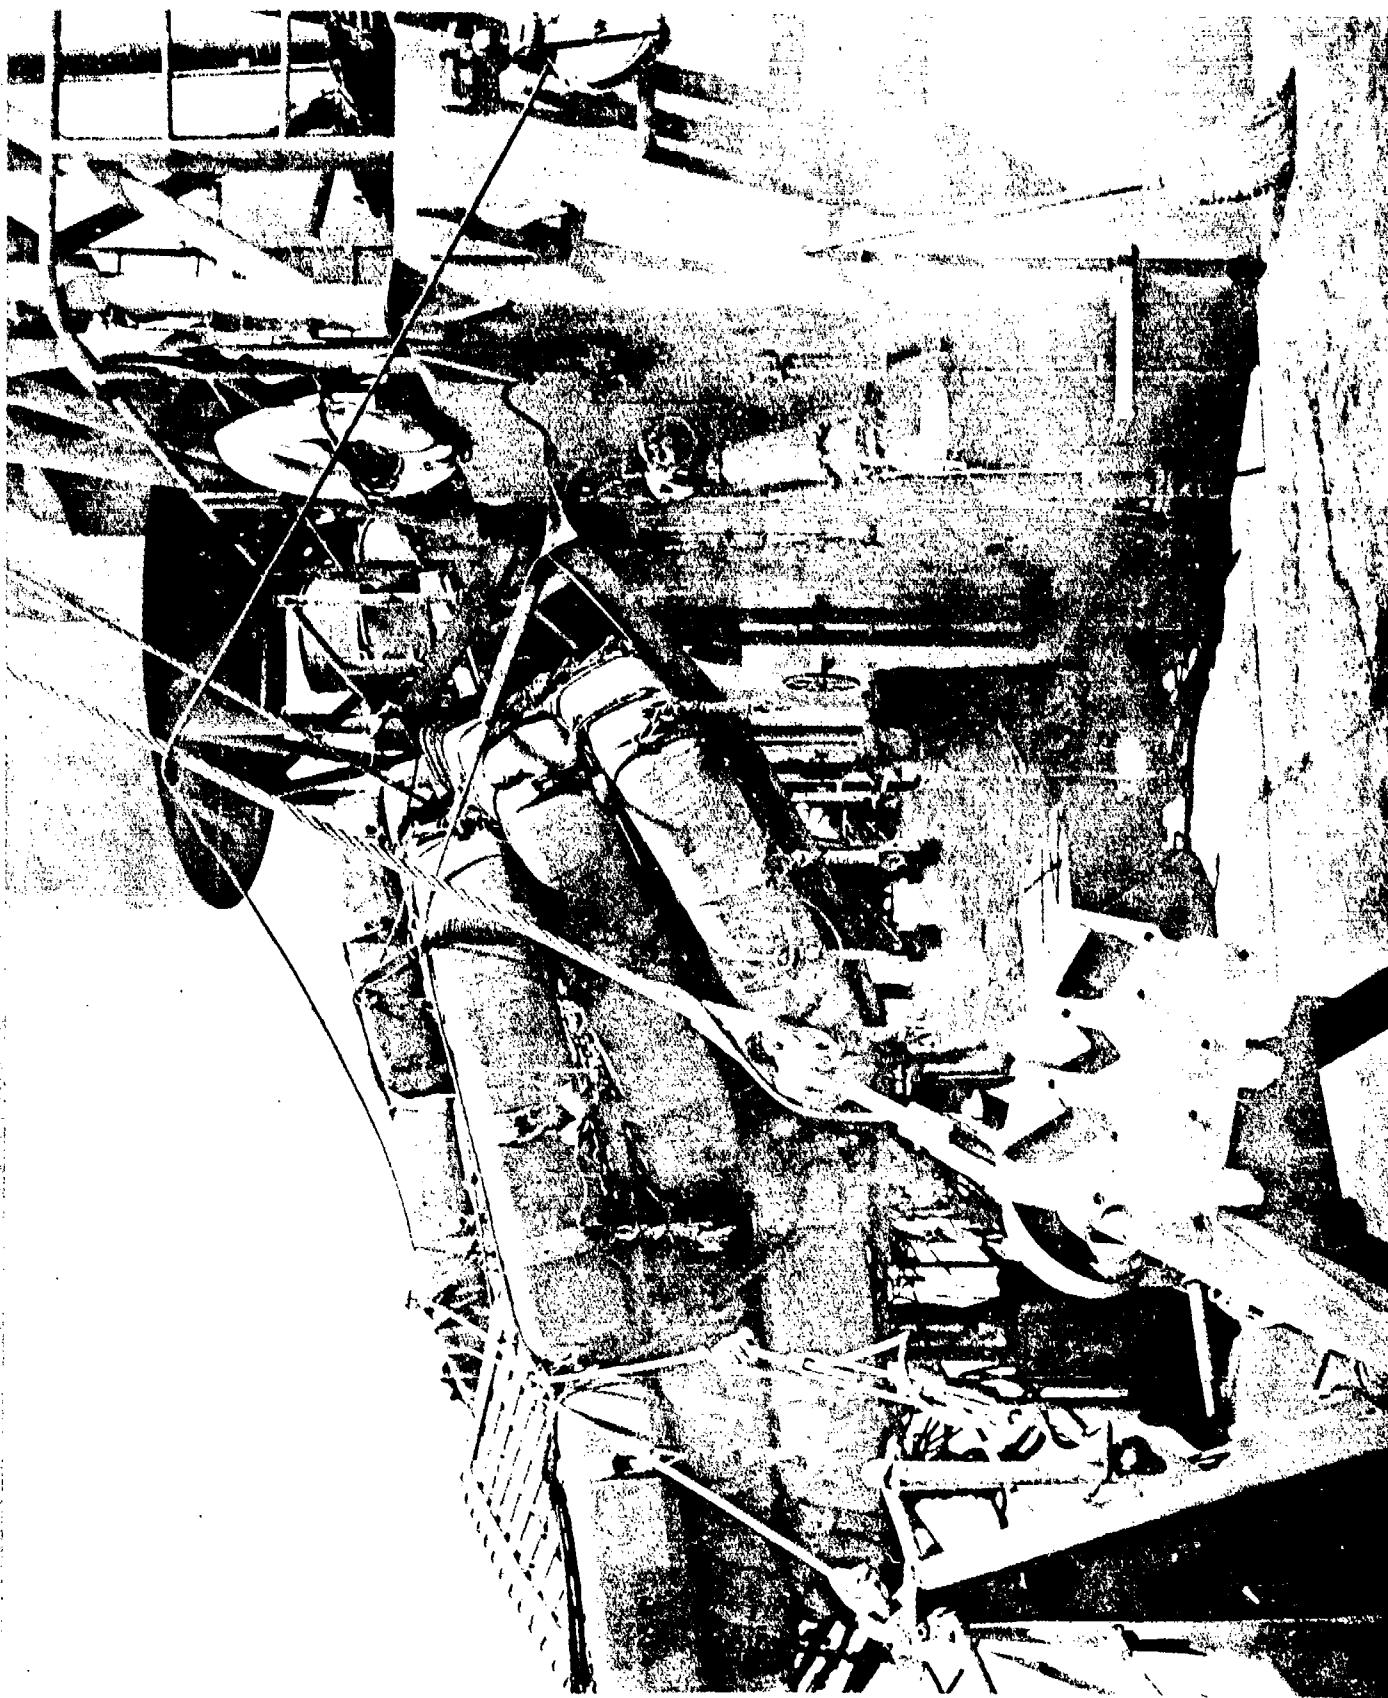
AA-CR-80-1906-8. Looking aft on upper deck, starboard, showing disarrangement of life raft stowage abreast starboard side of after deck house.

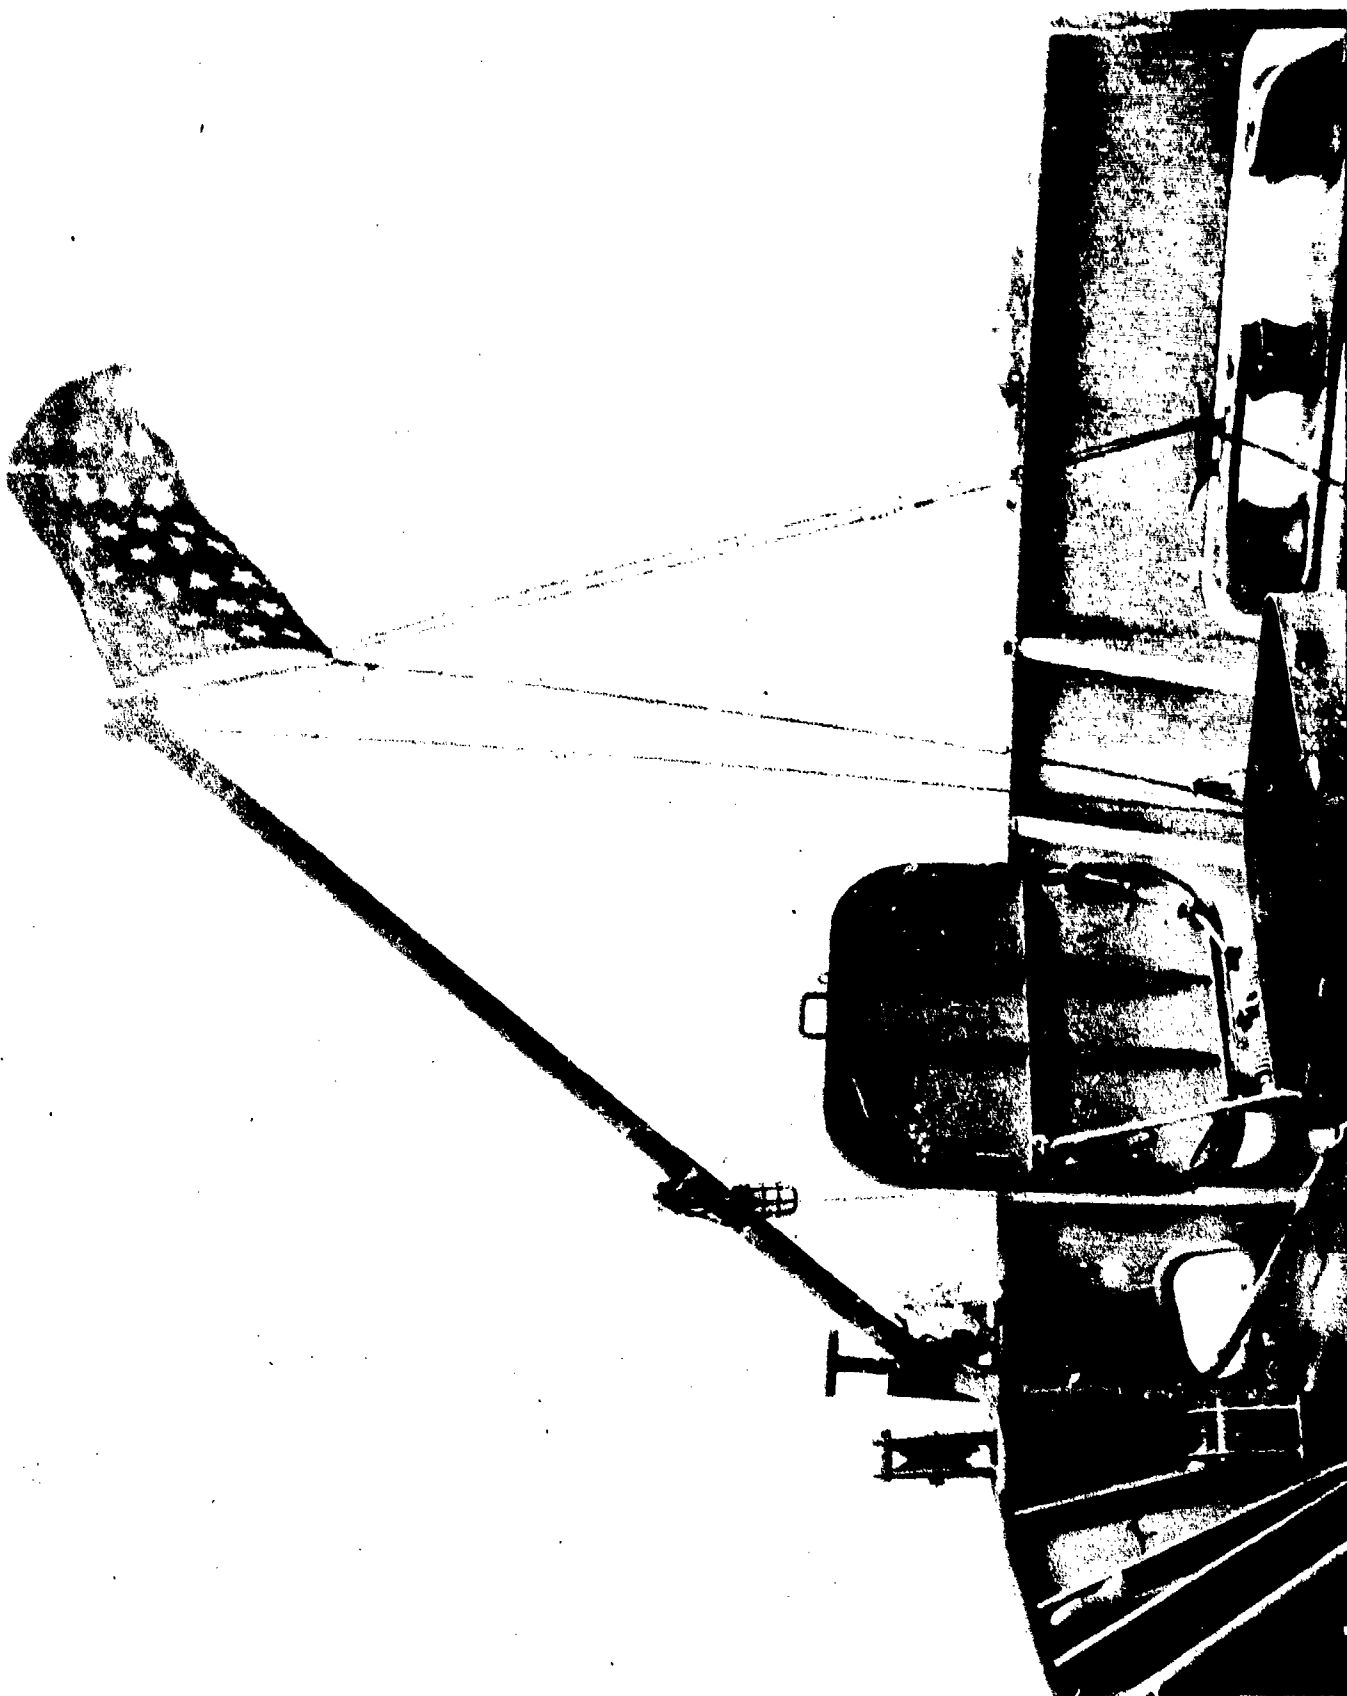
AA-CR-82-1921-11. Looking forward on upper deck at bow showing bent jackstaff.

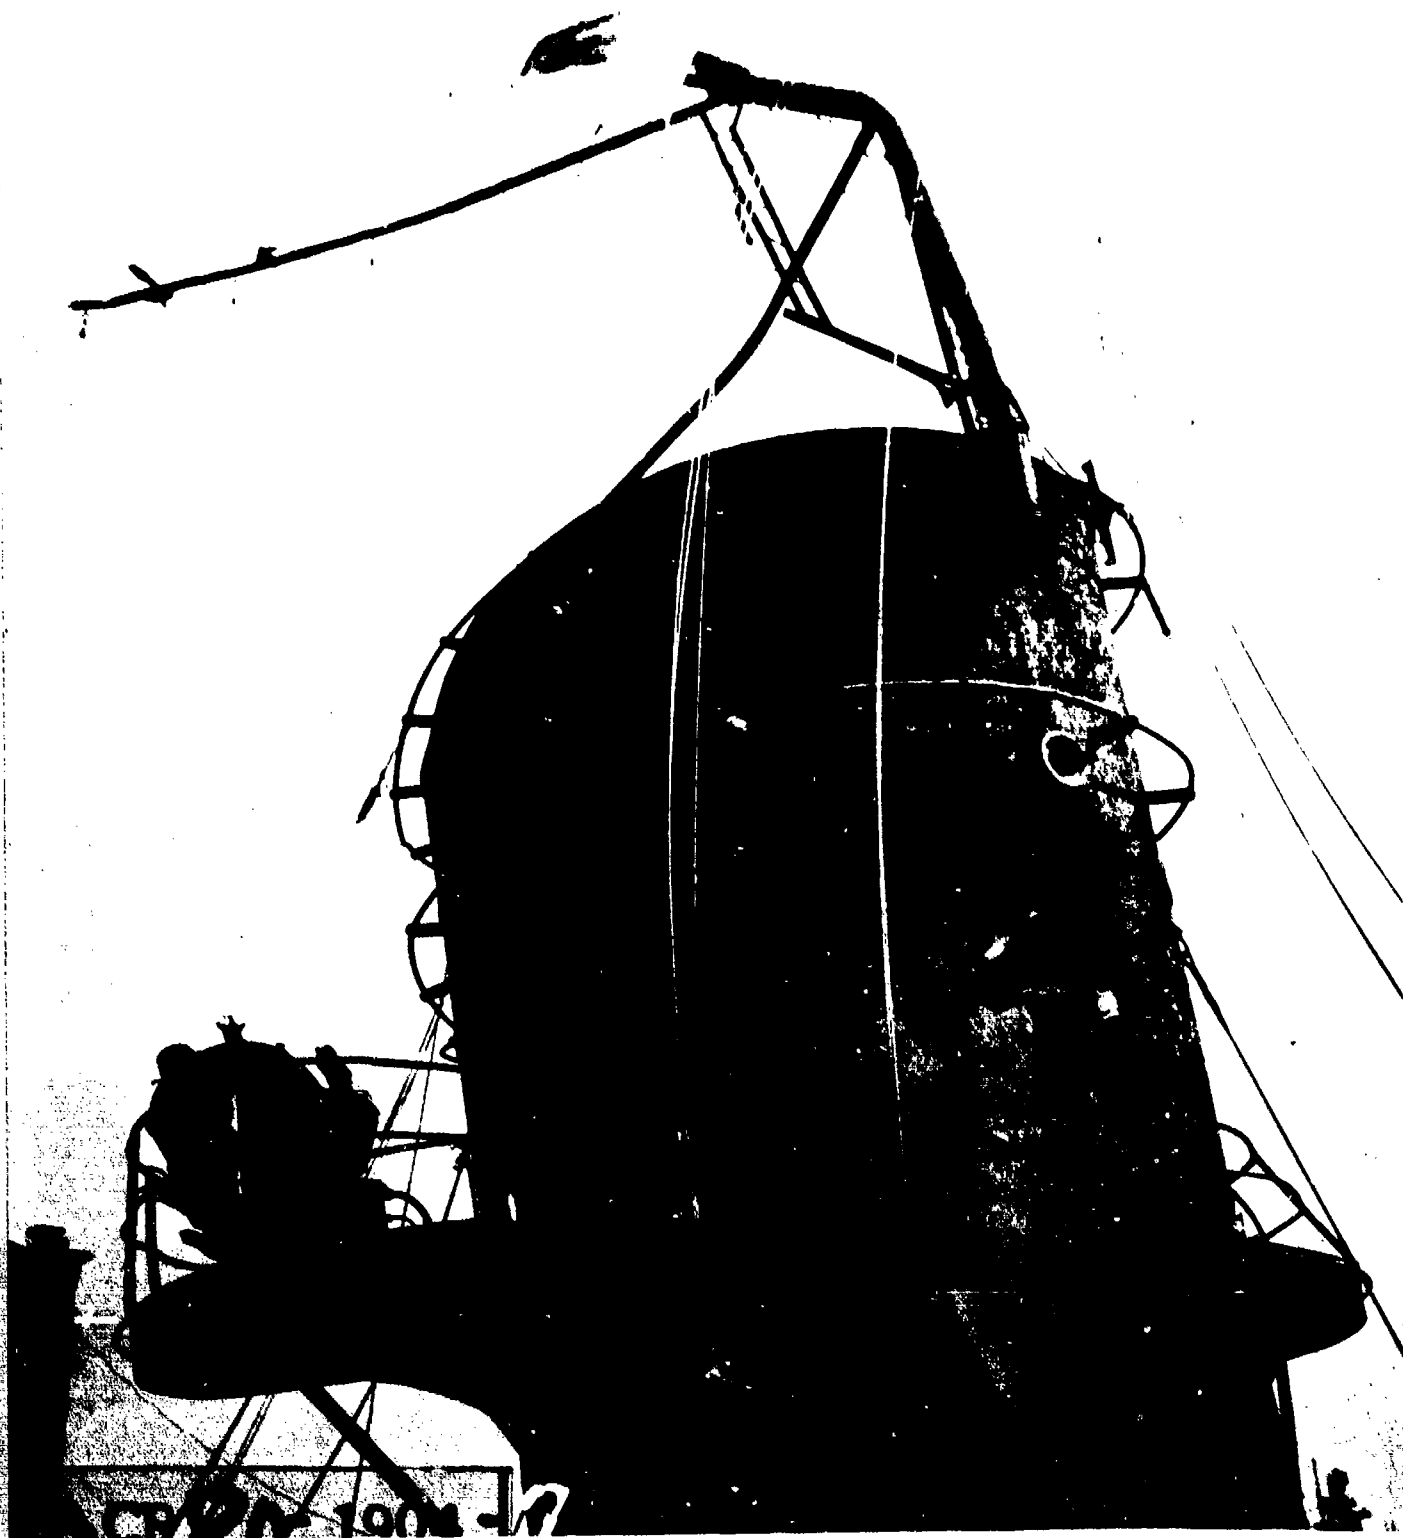
AA-CR-80-1904-7. Looking aft and to port from signal bridge level showing damaged 24 inch searchlight on starboard side of forward stack and bent stub mast.

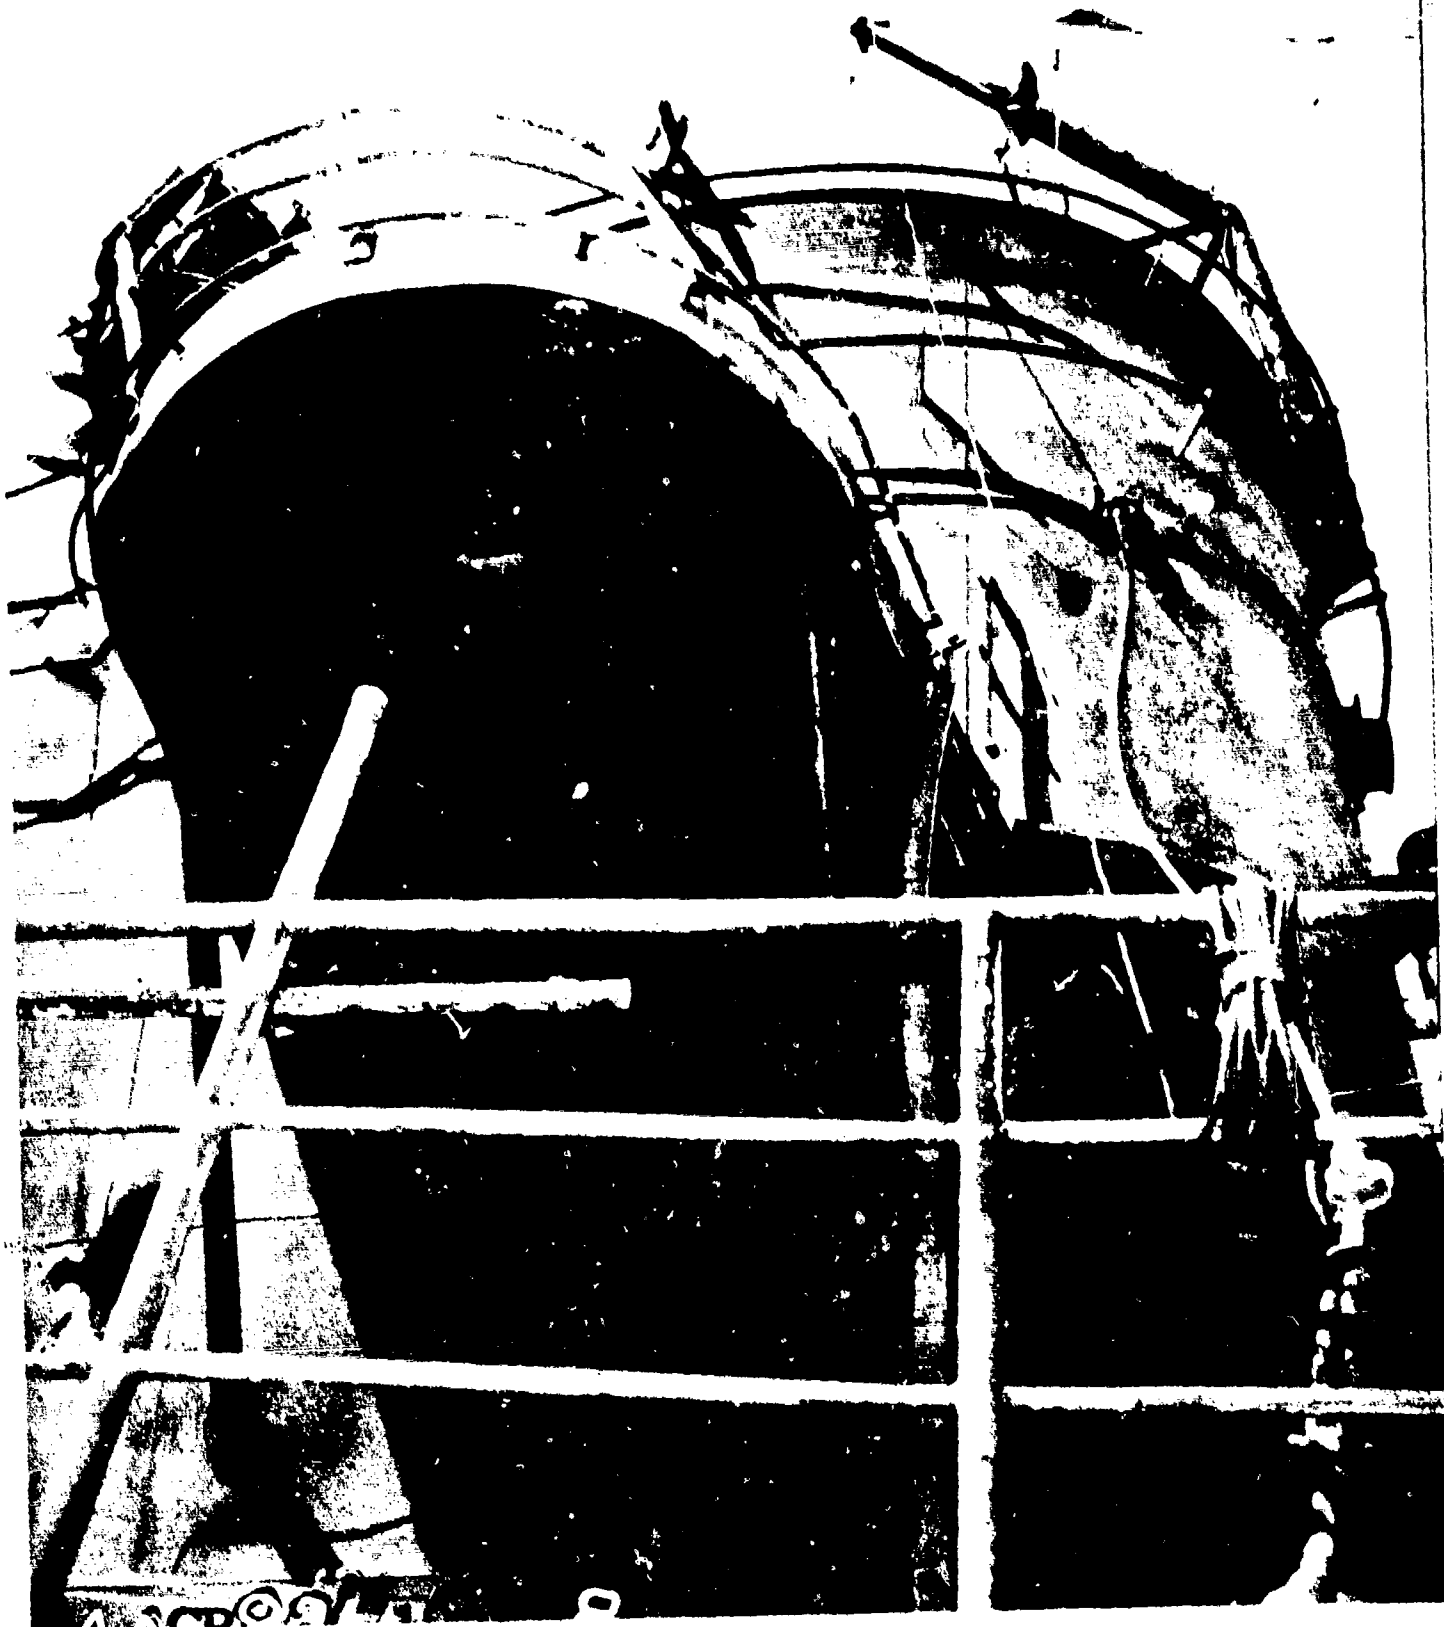
AA-CR-82-1922-8. Looking up and to port showing under side of searchlight platform on starboard side of forward stack and bent stub mast.

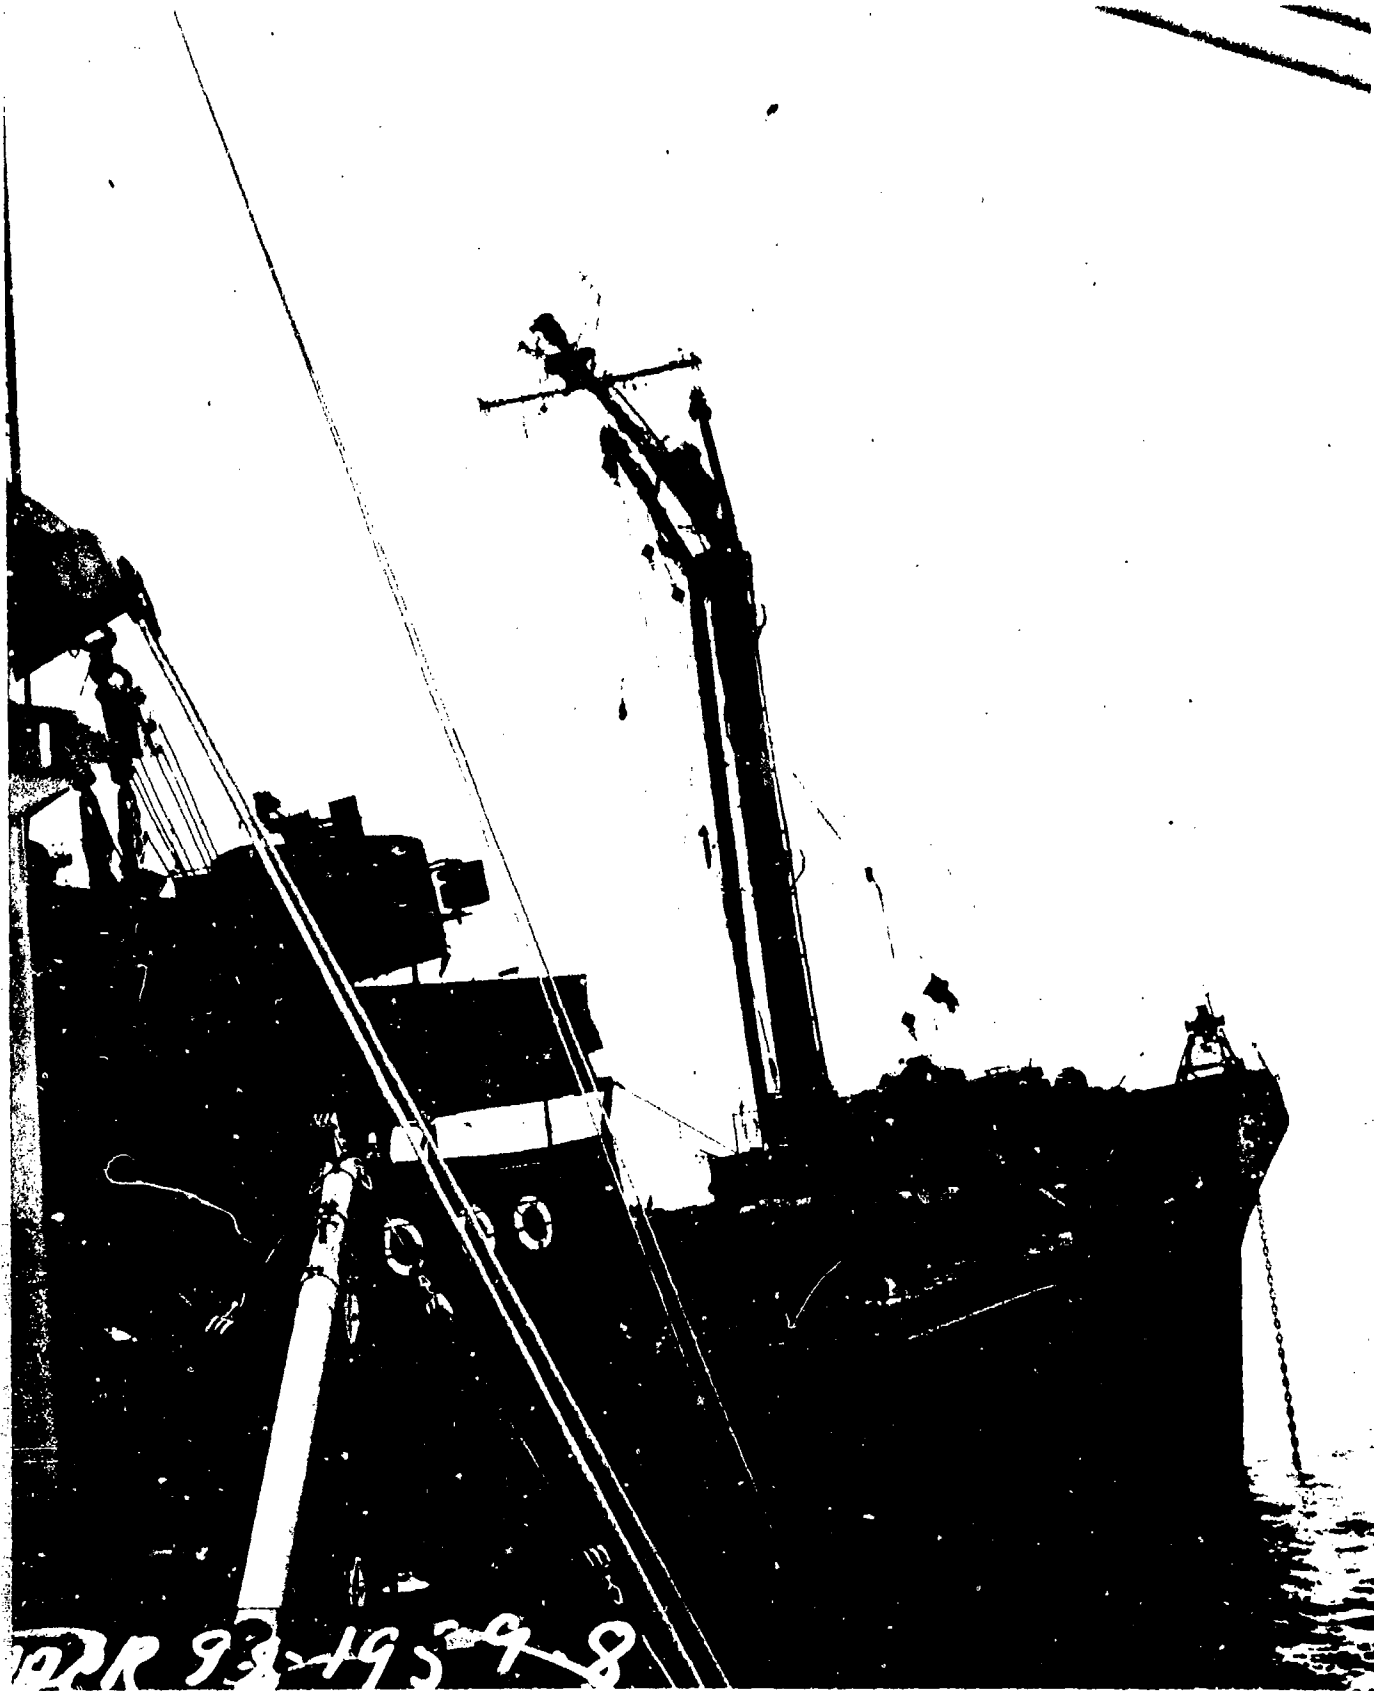
AA-CR-98-1959-8. Looking forward at starboard bow and wreckage on foremast.
